# Utilizing LiDAR as a Survey Tool on Buckhorn Mountain

Michael Drews, Jeremy Hall, MA, RPA, Gnomon Inc. Chris Noll, MA, RPA, David Harder MA, RPA, Plateau Archaeological Investigations, LLC

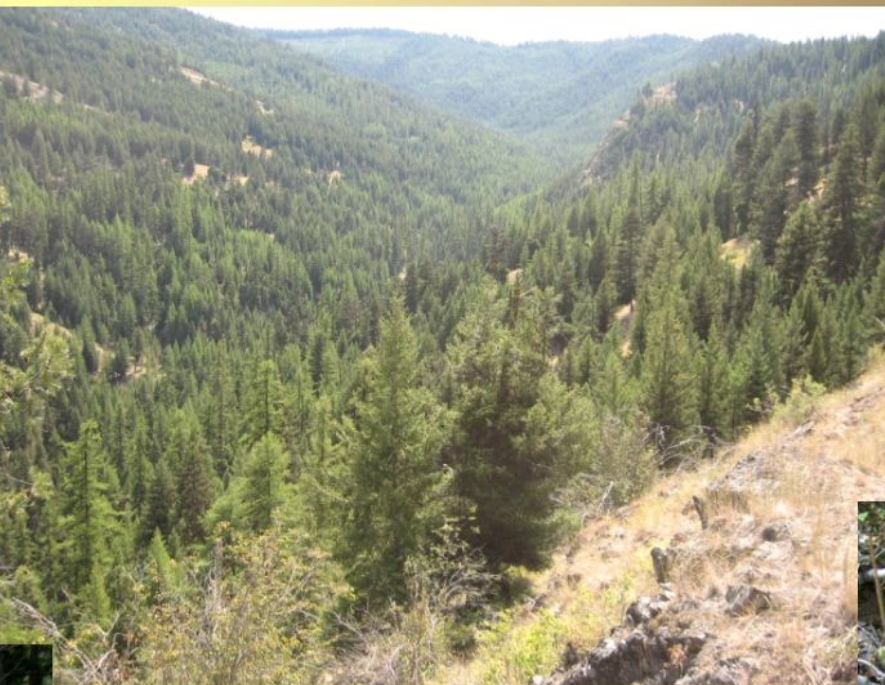
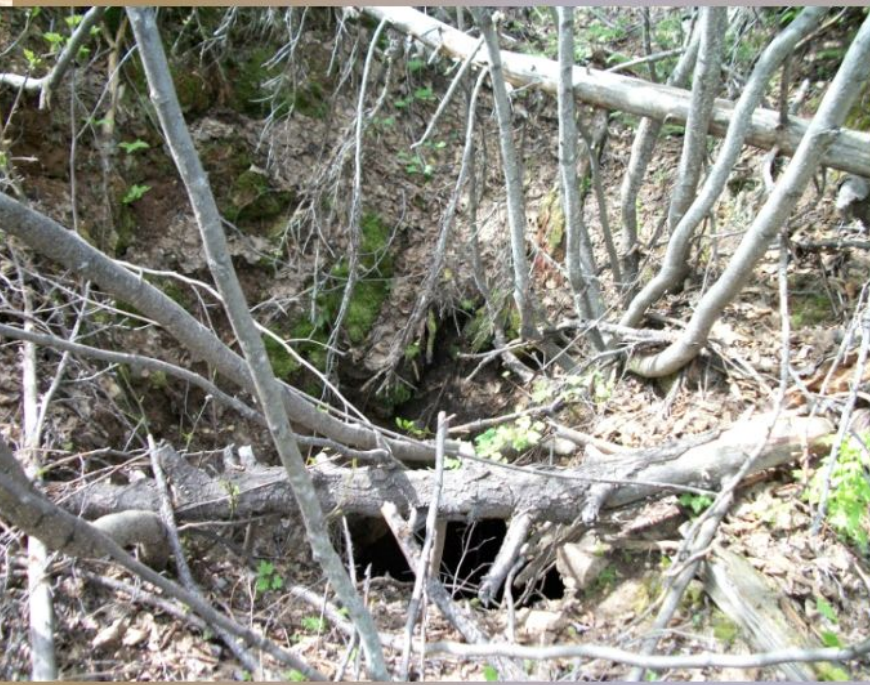
## Environmental Constraints

- Steep Slopes
- Heavy Vegetation
- Poor Surface Visibility
- Crew Safety
- Closed Areas/Limited Access
